BOOSTERS - TOO HOT TO HANDLE

by Ian Speer

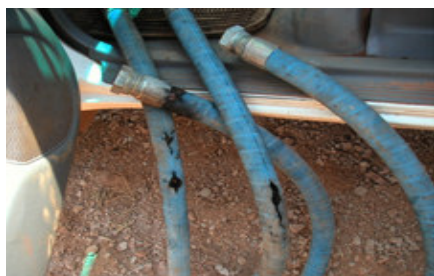
Hoses removed from M41B-870 after the first fire burned through from the inside.

In short, the unit was a Hurricane M41B-870, some eight years old, which had been overhauled several months ago. It had been functioning correctly when, without warning, it suffered an internal fire in the scrubber resulting in the inlet hoses to each cylinder burning through from the inside (Picture 1). There was no obvious reason for this event and I was asked to go to site and investigate the problem.

The booster required new valves, rings, cylinders, inlet hoses and a mesh filter for the scrubber tank. The remainder of the system was cleaned, the new parts fitted, and the booster was test run to ensure there were no mechanical problems.

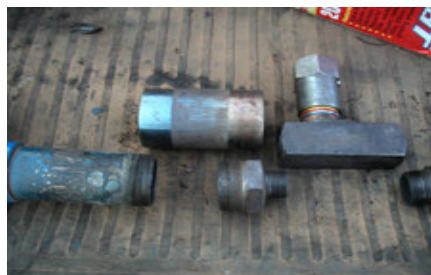
3. The throttle valve and coupling, as well as the inlet to the flowmeter that was at the seat of the fire. There was no significant rise in the temperature at the inlet to the throttle valve at the right of the picture; however, the coupling reached 482 °F.

The fire lasted for about two seconds and the heavy steel coupling (Picture 3) turned purple in this time as well as blistering the paint on the flowmeter and destroying my test gauge.

I was measuring the temperature of the coupling (482_F) and the main hose (240_F) to determine where the seat of the fire was and I was very pleased when the observers shut the system down!

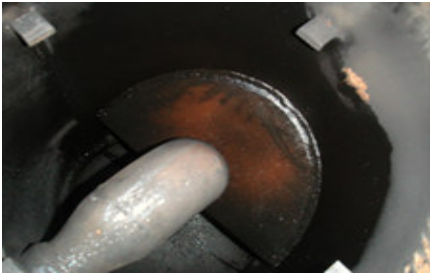
4. Film of oil on the interior of the scrubber after the incident. During testing, the fact that this was still in place is testament to the value of well-placed observers and good emergency shutdowns.

When the machines were shutdown the fire flashed back up inside the hoses through the booster bypass, into the scrubber (Picture 4), up through the mesh (Picture 5) and into the cylinders.

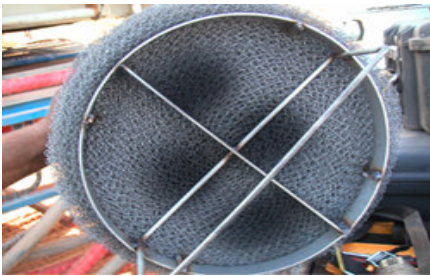
5. Passage of fire up through the new scrubber mesh element into the cylinders.

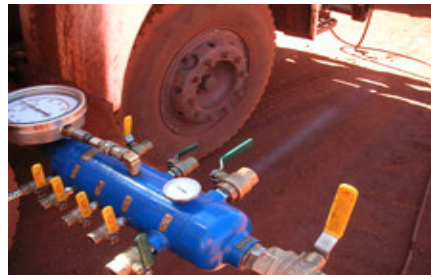
6. Shot of the oil carryover visible as a faint blue mist during another testing. The level of carryover requires LESS than 1 litre of oil per week and can sustain fire.

Picture 6 Shot of flowmeter showing oil carryover visible as a faint blue mist during other testing. This level of carryover requires LESS than 1 litre of oil per week and can sustain a fire.

1. Any oil carryover has the potential to fuel a fire.

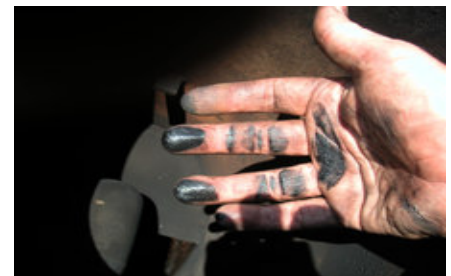
The booster scrubber was then dismantled (see picture 2) and there was only a suggestion of a film of oil inside the inlet from the auxiliary compressor, which, in the past would not have concerned me as the carryover was very small. A new separator was fitted to replace the unit in the auxiliary compressor that was passing oil and the whole set-up successfully retested.

2. Inside the scrubber after the first incident the interior was dry with only carbon residue; however, there was oil in the inlet pipe from the primary compressors.
